Broken Instrument Removal Kit

Instrument separation is one of the most common complications in root canal treatment process. The innovative design of instrument separation removal kit changes the traditional clinical methods. This design makes instrument separation removal process quick and easy.

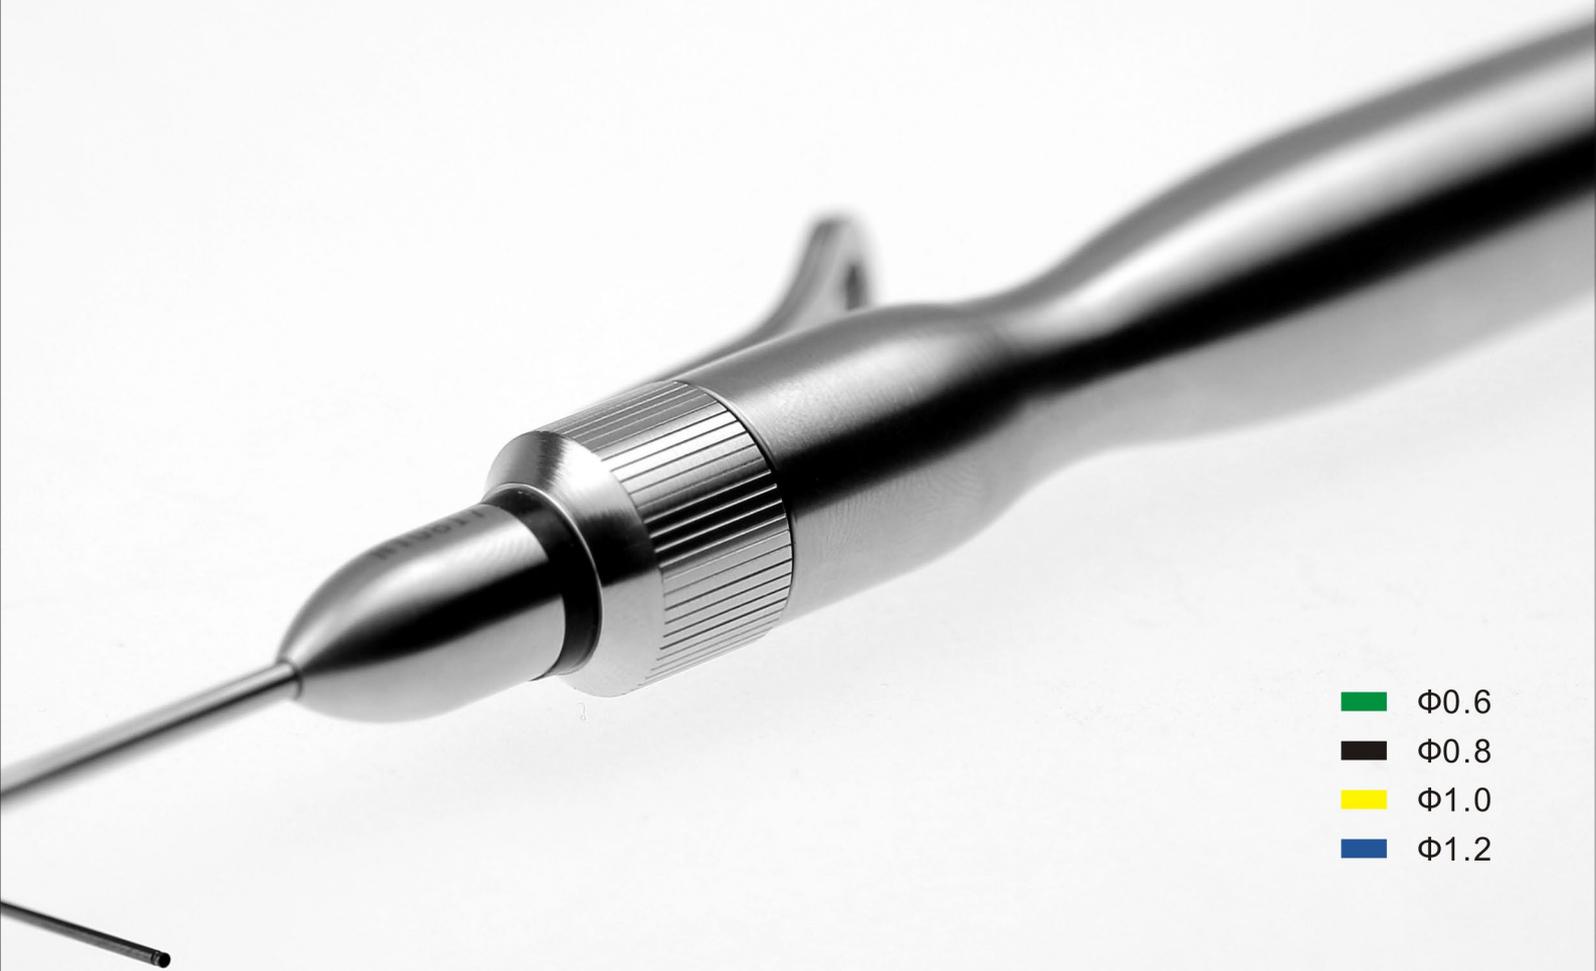
$\Phi 0.6$
-

$\Phi 0.8$
-

$\Phi 1.0$
-

$\Phi 1.2$

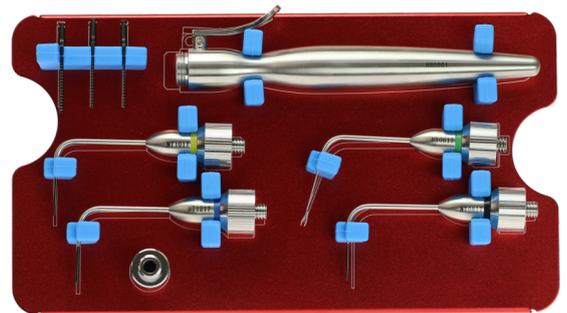
Φ0.6

Tip of crab-claw-shaped tweezers
Φ0.6x21

Φ0.8

Tip of extractor
Φ0.8x21

Φ1.0

Tip of extractor
Φ1.0x21

Φ1.2

Tip of extractor
Φ1.2x21

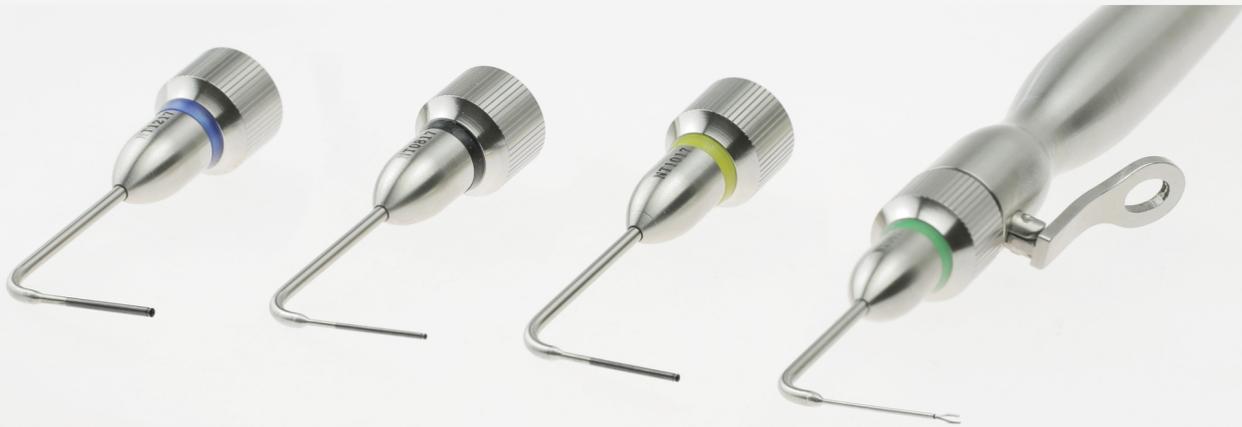
Φ0.8 Φ1.0 Φ1.2

Trephine bur, L:21mm

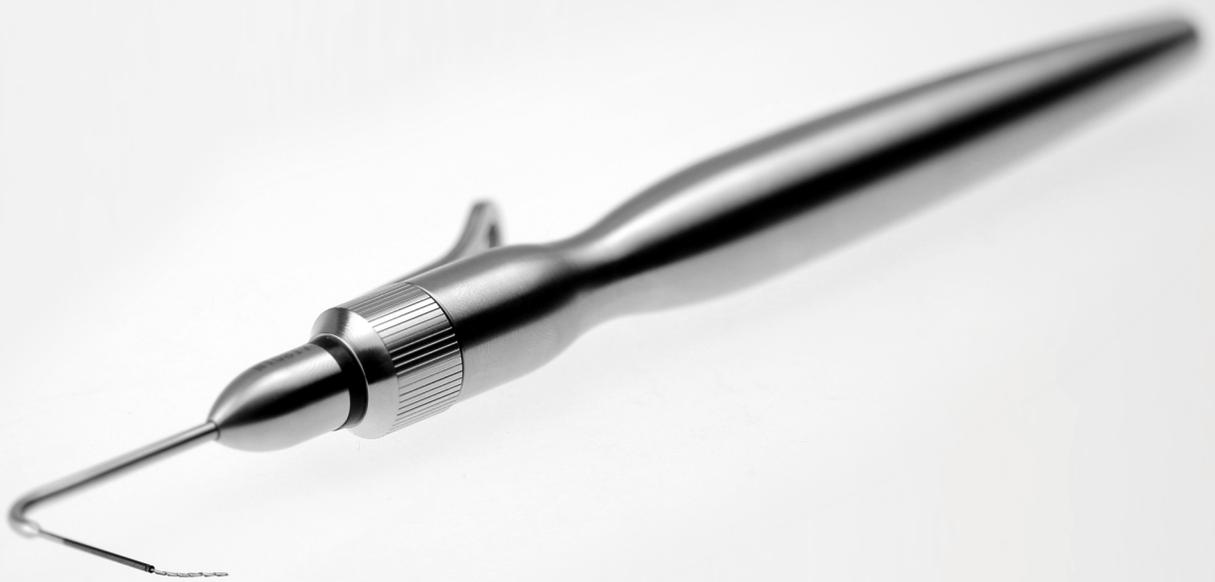
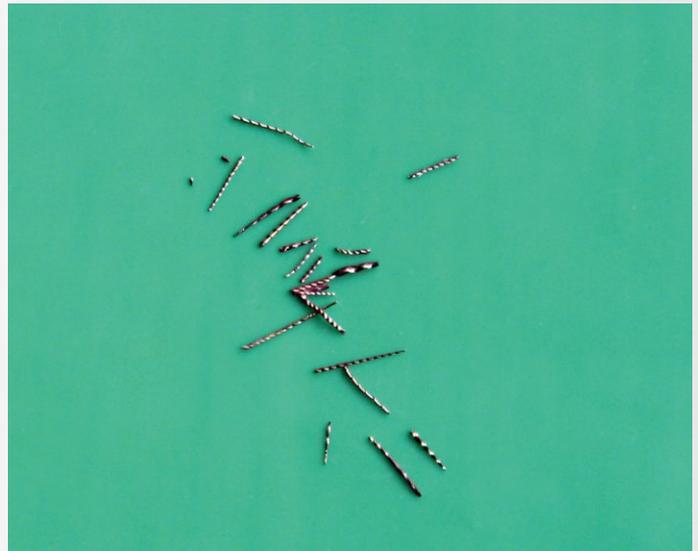
Photo provided: research and training center of oral microscopy technology, School of Stomatology, Wuhan University
